# MS-5024UD/MS-5024UDE Field Software Change Procedure

Document 50125 Rev M 7/15/05 ECN 05-429

## Firmware Change

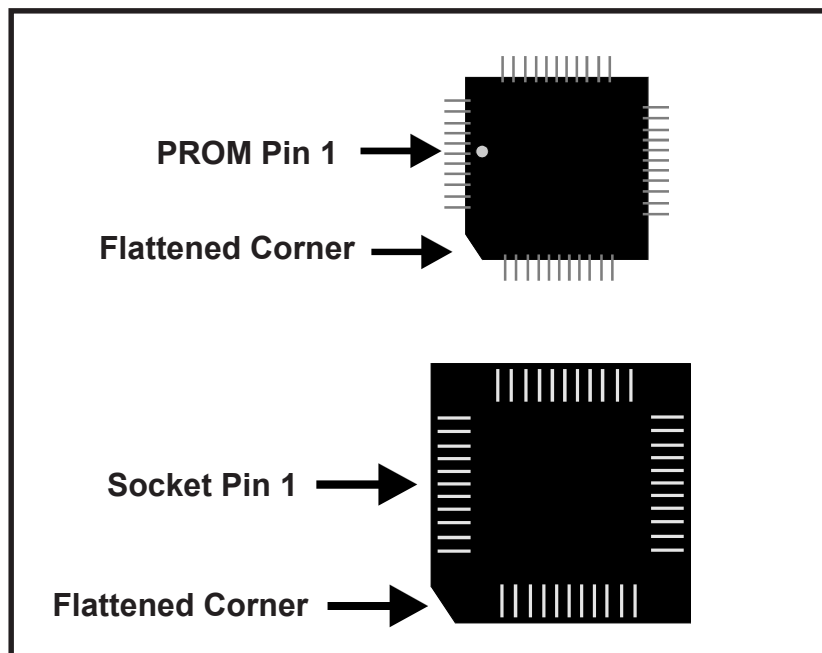
Observe proper orientation of any IC removed or installed! Note location of Pin 1 with respect to the flattened corner and dot on the body of the IC and the relationship to the flattened corner on the IC socket. The replacement PROM must be installed in the same manner as the PROM removed. Failure to observe this orientation will result in destruction of the PROM.
