HONEYWELL POWER PRODUCTS

TB20.1HP

HWF2A-COM / HWF2V-COM Potential Communication Issue
Over-the-Air Firmware Update Required

November 10, 2020

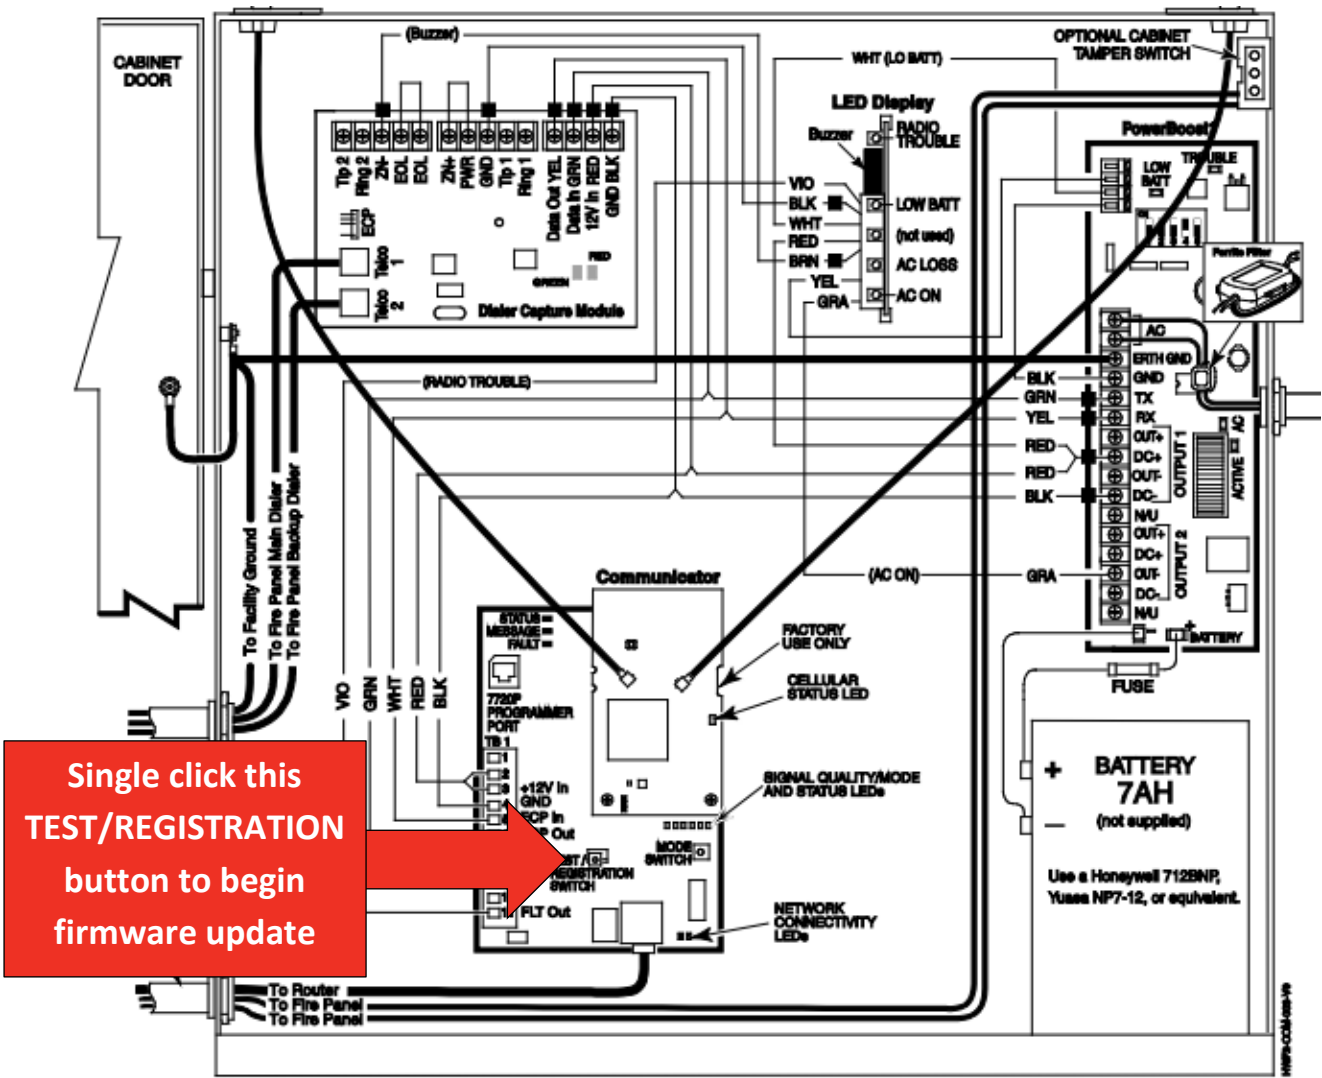
DIAGRAM A:

This process should take no longer than ten minutes. See Diagram A below for the location of the Test/Registration switch.

Firmware updates can be initiated on site by **clicking the Test/Registration switch one time** to generate a test message to AlarmNet, which will initiate the firmware update process. If your communicator already has the latest firmware, the test process will complete, and the firmware update process will not start.
