Customer Advice Note CAN #176

MPI Registration Failure

Date: April 2023

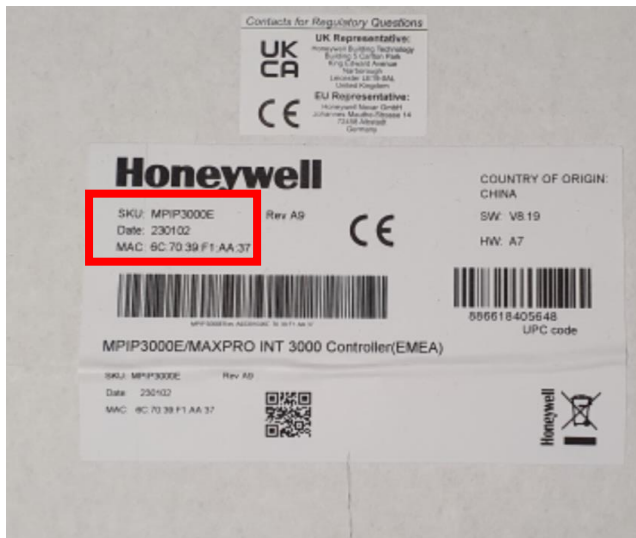
The date code is displayed on the main control panel box.

Please follow the normal returns process if your panel fails to register on installation and has been manufactured between the dates stated .
