**Customer Advice Note  
CAN #142**

**Galaxy RIO C072  
Jumpers**

**Date: August/2021**

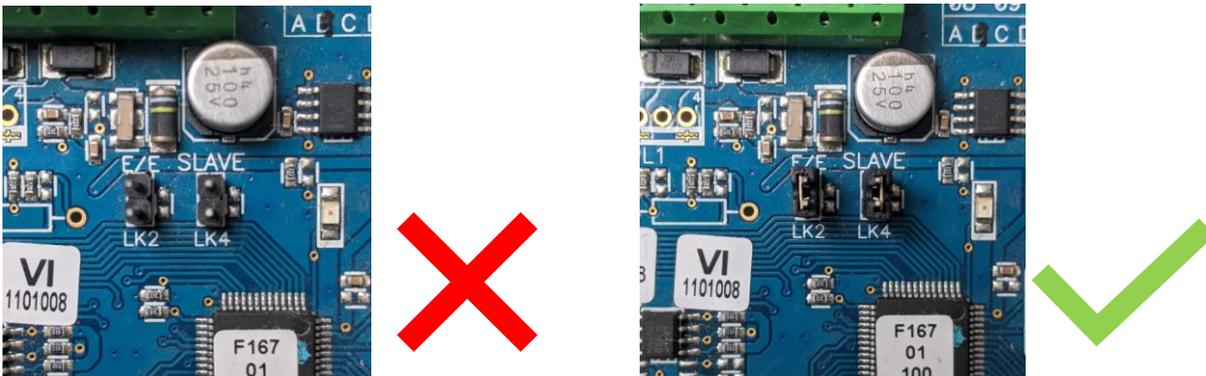
This Customer Advice Note details a problem with the Galaxy RIO (**C072**) Jumpers  
A number of the Galaxy RIO have shipped with the jumpers **LK2** and **LK4** open on the PCB.

When LK2 and LK4 are removed the RIO is configured for a standalone feature which is not compatible with connection to a Galaxy control unit. Enrolment of RIO in this configuration results in the zones being unresponsive.

## Attention: Resolution

Please fit 2 Jumper links to close **LK2** and **LK4** as per picture above.

**NOTE: If RIO is added to the system please remove from the RS485 and re-add with Jumpers pre-fitted.**
