# MS-5012 Field Software Change Procedure

Document 50194 Rev B 3/16/95 ECN 95-133

## Firmware Change

This procedure outlines the mechanical installation steps required to install a PROM in the MS-5012.

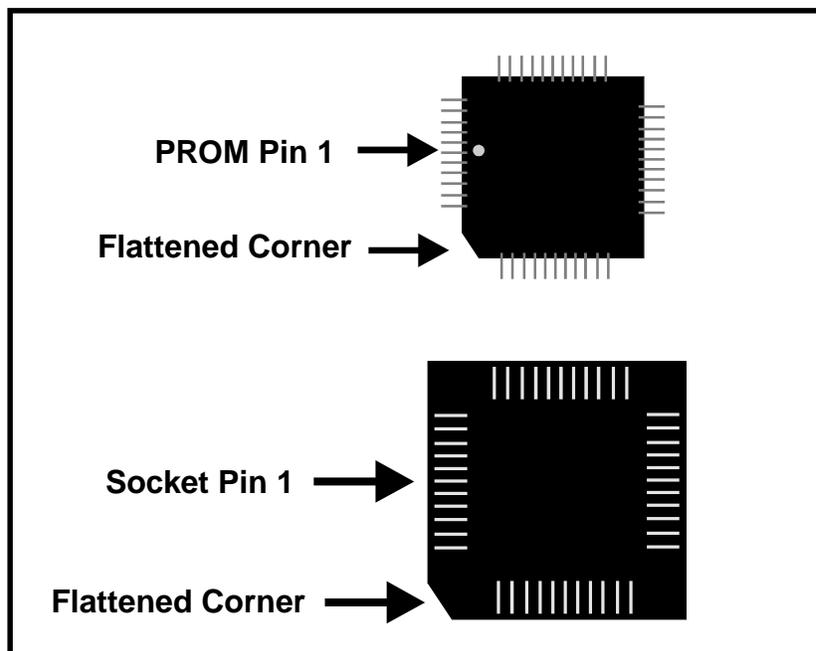
Observe proper orientation of any IC removed or installed! Note location of Pin 1 with respect to the flattened corner and dot on the body of the IC and the relationship to the flattened corner on the IC socket. The replacement PROM must be installed in the same manner as the PROM removed. Failure to observe this orientation will result in destruction of the PROM.

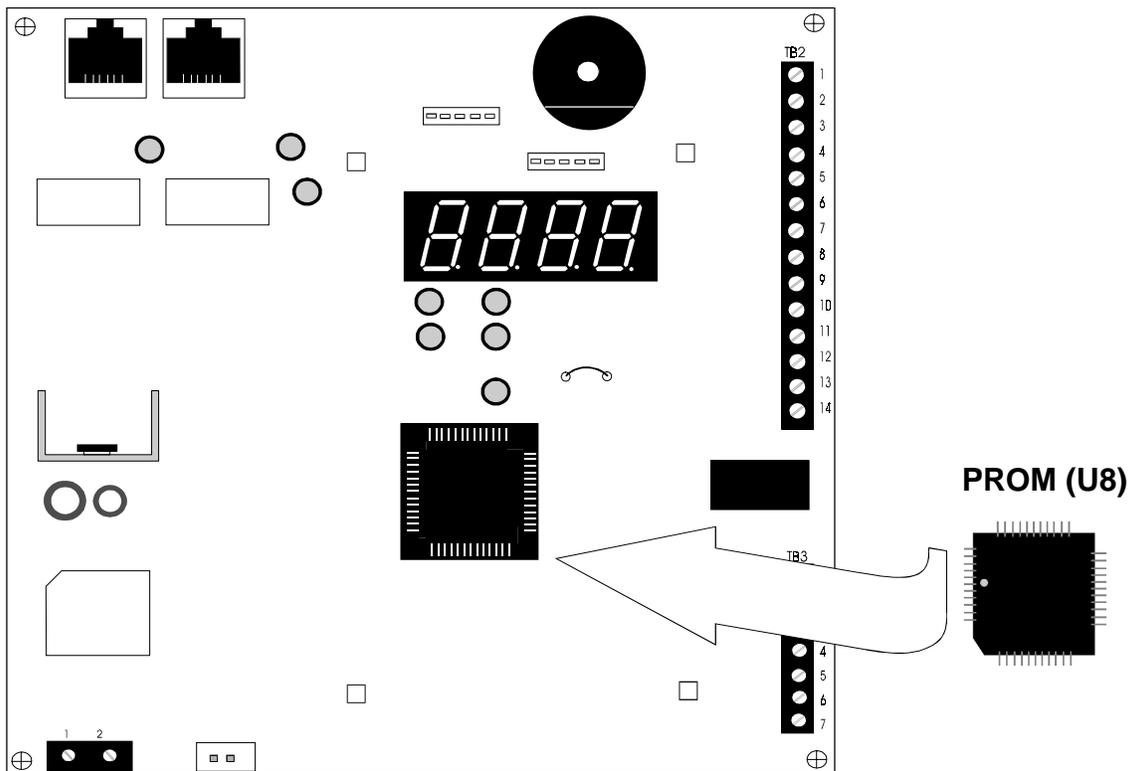
1. Once all power has been removed, disconnect any option modules (if installed).
2. Gently remove membrane keypad from circuit board, but do not disconnect cable from circuit board. (Note that the keypad's four supports snap into the circuit board).
3. Locate U8 (center of the board).
4. Gently loosen and remove the PROM from U8.
5. Install the replacement PROM in location U8. Observe proper orientation! The dot on the IC should be positioned to the left and the flattened corner of the IC should align with the flattened corner of the socket. Use care to insure that the PROM's pins are not bent or broken during insertion.
6. Reconnect power supplies.
